**National Highway
Traffic Safety
Administration**

Case Vehicle (A): 2000 Buick
 Type: Regal GS, 4-door sedan
 Driver: 40-year-old male
 CDC: 12-FDEW-5

SITUATION

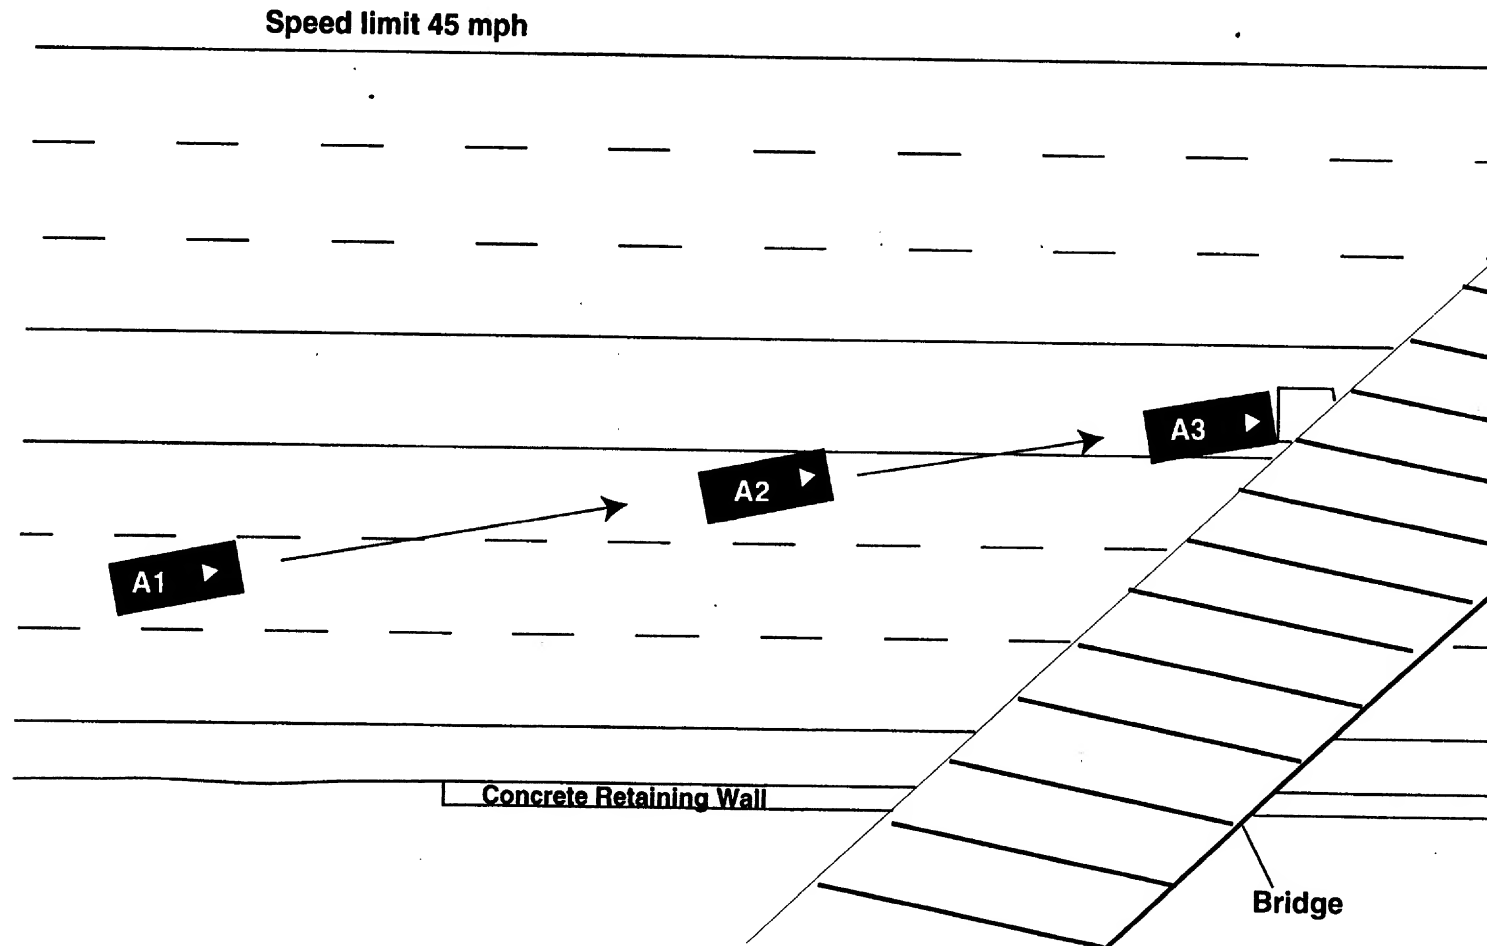
ACCIDENT SCHEMATIC

ACCIDENT DESCRIPTION: Case vehicle (A) was traveling north in the middle northbound lane of a straight section of a dry asphalt, six-lane divided roadway. For an unknown reason, the driver of

case vehicle (A) veered across the inside northbound lane, entered a concrete median with mountable curbs, and struck a bridge abutment head-on in a full frontal mode. After impact, case vehicle (A) rebounded away from the abutment and came to rest in the median facing north.

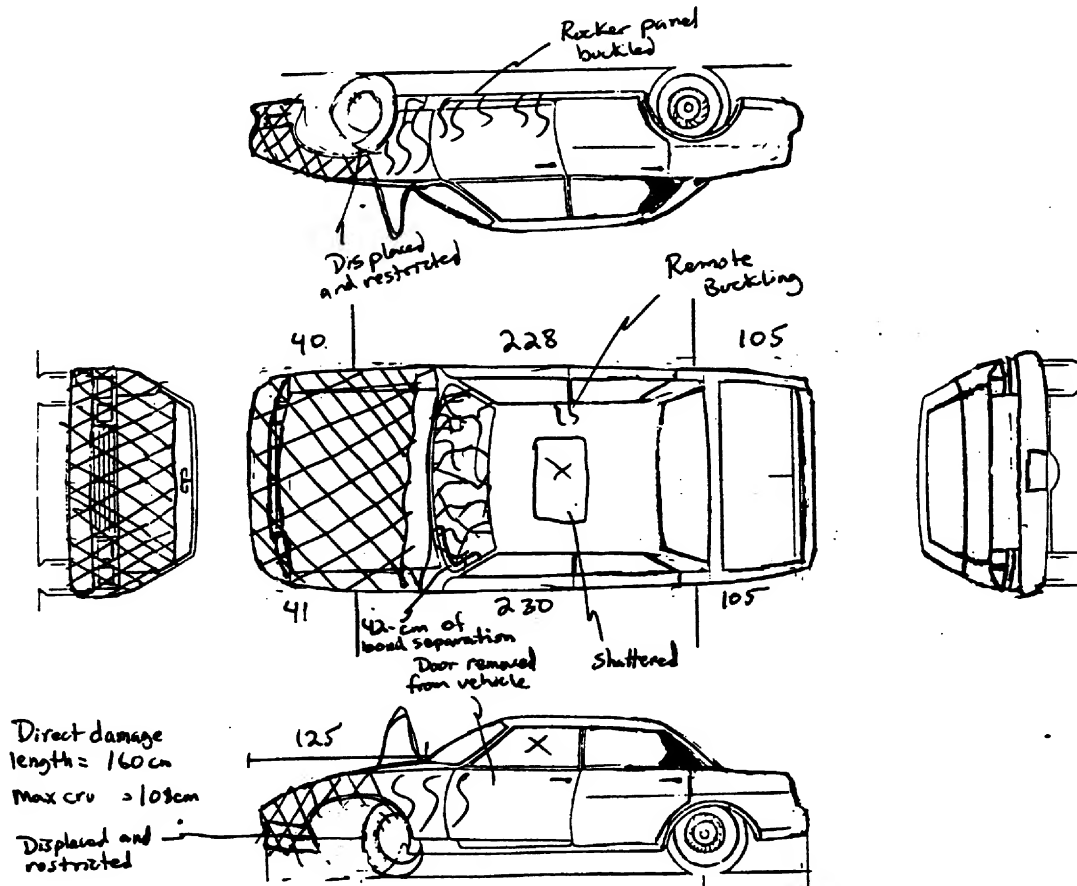
VEHICLE DAMAGE

(Slide 4) Damage to case vehicle (A) was severe. The direct-damage length was 160 cm and began at the right-front bumper corner. The maximum crush was 108 cm and occurred 54-cm inboard from the right-front bumper corner. The right wheelbase was reduced 49 cm, and the left wheelbase was reduced 47 cm.

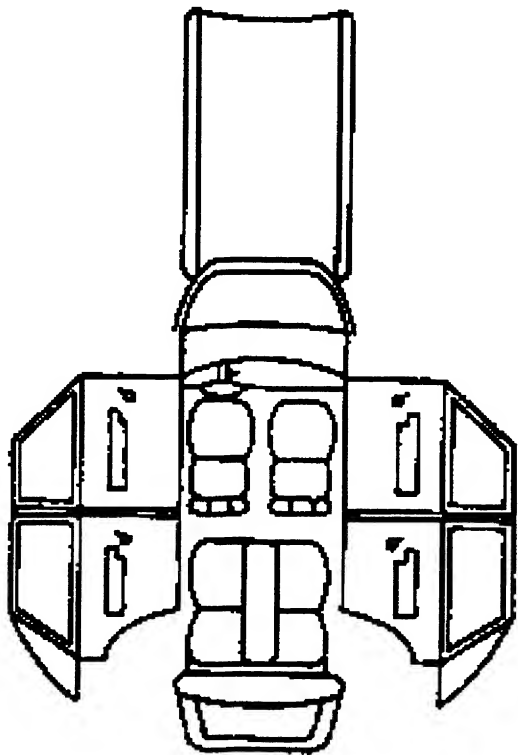
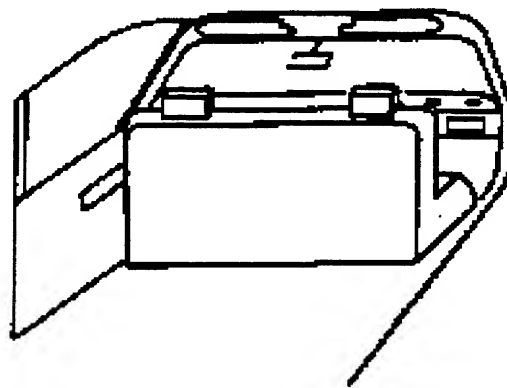
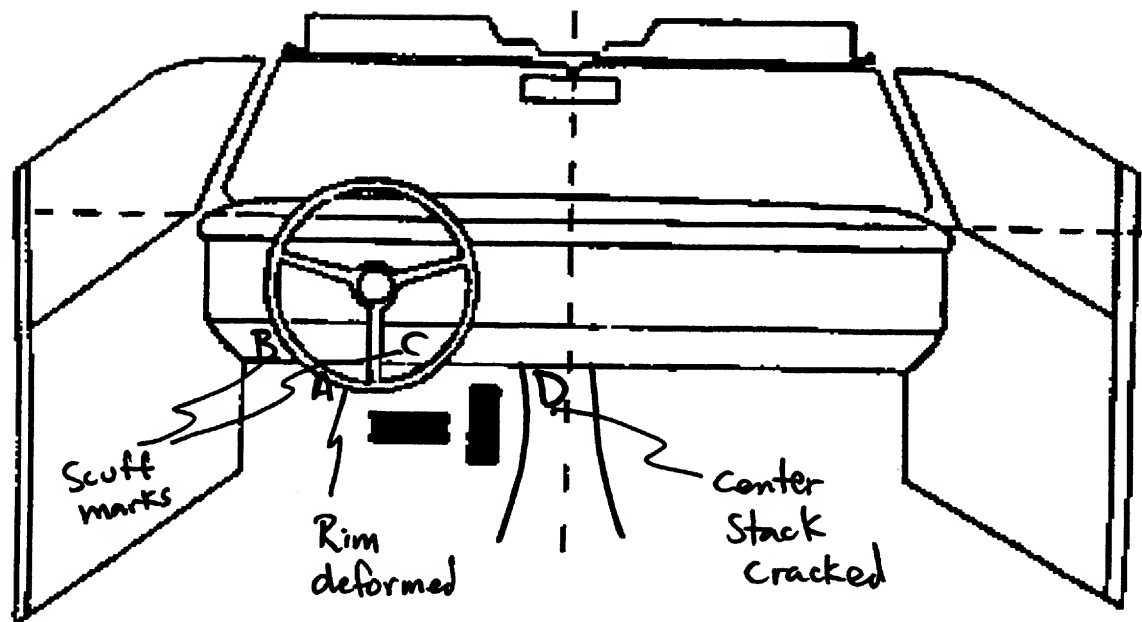
VEHICLE OCCUPANT CONTACT DIAGRAM

Contact	Interior Component Contacted	Occupant No. if Known	Body Region if Known	Supporting Physical Evidence	Confidence Level of Contact Point
A	SW rim	1	face/chest	rim deformed	1
B	Knee bolster	1	Knee	Scuff marks	1
C	Knee bolster	1	Knee	scuff marks	1
D	ctr stack	1	hip	cracked	1
E					
F					
G					
H					
I					
J

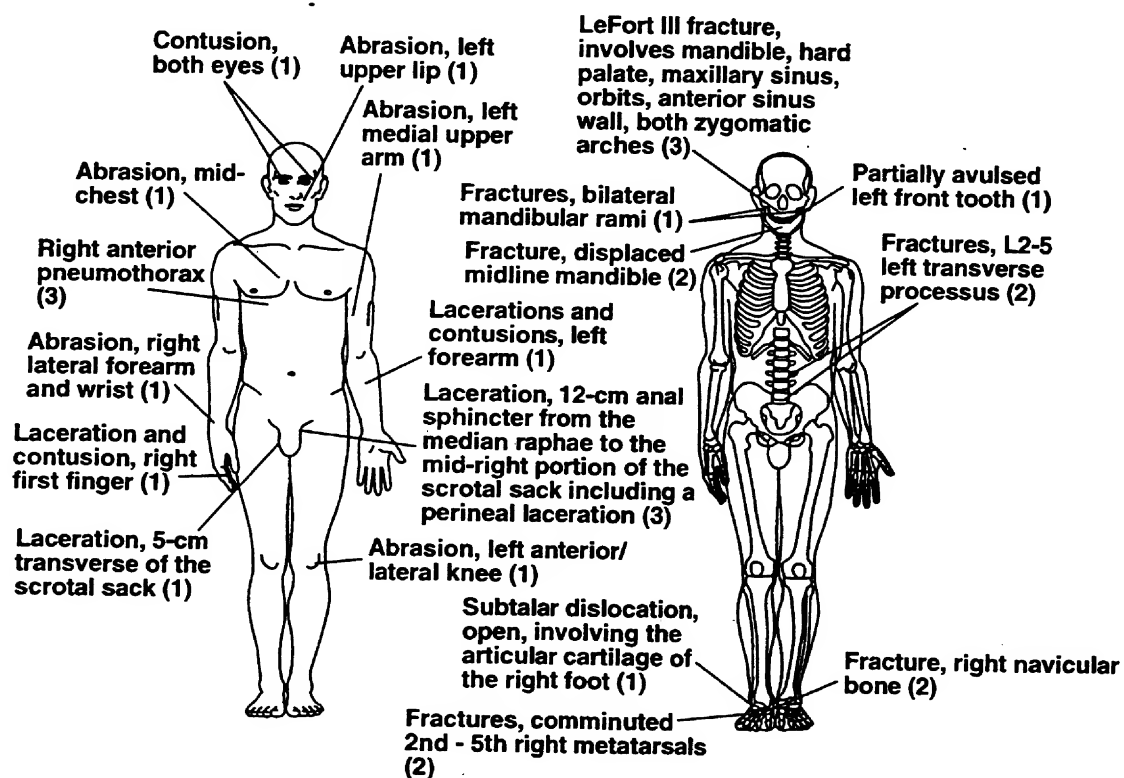
INDICATE LOCATION OF INJURIES.

Injury Description	A.I.S.	Injury Source		
		Definite	Probable	Possible
Contusion, both eyes	1		Airbag	
Abrasion, left upper lip	1		Airbag	
Abrasion, left medial upper arm	1		Airbag	
Le Fort III fracture, involving the mandible, hard palate, maxillary sinus, orbits, anterior sinus wall and both zygomatic arches	3		Steering-wheel rim/upper instrument panel	
Fractures, bilateral mandibular rami	1		Steering wheel rim/upper instrument panel	
Fracture, displaced midline mandible	2		Steering wheel rim/upper instrument panel	
Partially avulsed left tooth	1		Steering wheel rim/upper instrument panel	
Abrasion, mid-chest	1		Steering wheel	
Right anterior pneumothorax	3		Steering wheel	
Fractures, left transverse process of L2 -5	2		Twisting of torso	
Laceration, anal sphincter, 12 cm	3		Seat	Lower instrument panel; foot pedals
Laceration, scrotal sack, 5 cm	1		Seat	Lower instrument panel; foot pedals
Abrasions, right forearm	1		Instrument panel

Abrasions, right wrist	1		Instrument panel	
Laceration, 1 st right finger	1		Instrument panel	
Contusion, 1 st right finger	1		Instrument panel	
Laceration, left forearm	1		Flying glass	Instrument panel
Contusion, left forearm	1		Instrument panel	Interior door surface
Abrasion, left anterior/lateral knee	1	Knee bolster		
Open subtalar dislocation, involving the articular cartilage of the right foot	1		Accelerator pedal/toe pan	
Fracture, right navicular bone	1		Accelerator pedal/toe pan	
Fracture, comminuted, 2 nd -5 th right metatarsals	2		Accelerator pedal/toe pan	
<u>Maximum A.I.S. Level</u>	<u>3</u>			
<u>Injury Severity Score</u>	<u>27</u>
